**Flood Control Project Maintenance  
Levee Inspections**

## Maintenance Issue Types Only, Levee Inspection Report By Mile - Spring 2019

### Reclamation District No. 0524 Middle Roberts Island

Waterway	Bank	Unit Miles	Inspection Start/End	Inspector
Unit No. 01 San Joaquin River	Left	6.20	03/26/2019 03/27/2019	Alberto De Leon

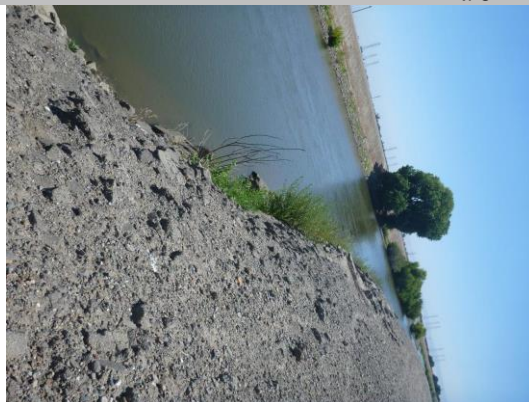
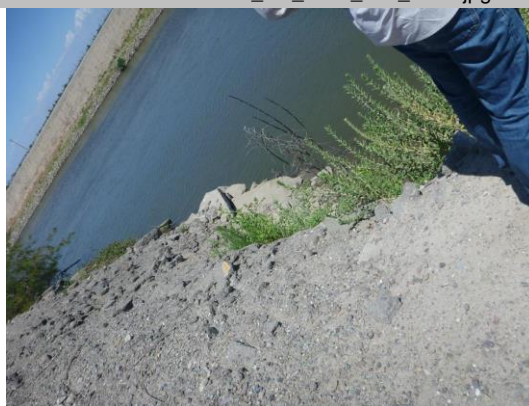
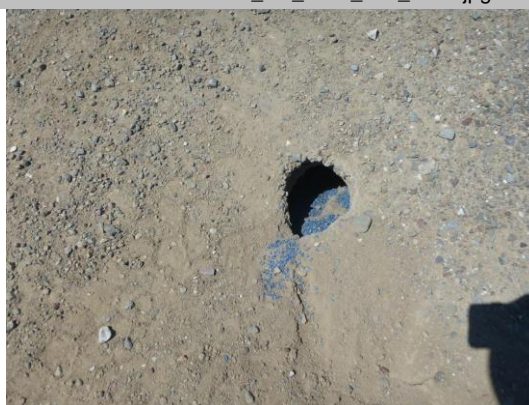
Comment Code					
Inspector Comment					
Levee Evaluation Comments					
Description:Slope protection repairs are needed along the waterside slope due to erosion. Based upon levee inspections, it was determined the waterside levee slopes were eroding, deteriorating and degrading in concave pocket sections at various locations along this levee reach. The eroded levee sections need to be restored back to design standards to prevent further deterioration of the damaged levee sections.					
Site ID No:468					
Site Designation:LMA-295					
Repair Type: Erosion					
Rating:Serious					
Field Date:7/26/2017					
Notes: Serious because erosion is impacting the levee, but there is some slope protection here. Slope is armored with asphalt and concrete rubble. The surrounding slopes are pretty baren, but there is a small bush within the site so it may be older.

Item	2017 Storm Damage		37.892200 °		°					
			-121.328000 °		°					
DWR ID	DWR_RD0524_01_f_2017_235									
Comment Code										
Inspector Comment										
<p>Levee Evaluation Comments</p> <p>Description: Slope protection repairs are needed along the waterside slope due to erosion. Based upon levee inspections, it was determined the waterside levee slopes were eroding, deteriorating and degrading in concave pocket sections at various locations along this levee reach. The eroded levee sections need to be restored back to design standards to prevent further deterioration of the damaged levee sections.</p> <p>Site ID No: 468</p> <p>Site Designation: LMA-295</p> <p>Repair Type: Erosion</p> <p>Rating: Serious</p> <p>Field Date: 7/26/2017</p> <p>Notes: Serious because erosion is impacting the levee, but there is some slope protection here. Slope is armored with asphalt and concrete rubble. The surrounding slopes are pretty barren, but there is a small bush within the site so it may be older.</p>

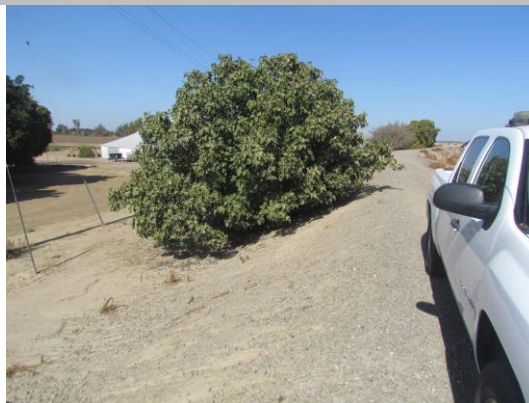
Photo 1 of 1 : SP\_2019\_RD0524\_107\_67\_20190313\_00093.jpg

LM Start	4.70	Rating **	M	Issue No.	67
LM End	4.70	Issue Type +	Ma	Location *	LS
Category	Earthen Levee			GPS Latitude/Longitude	
				Start	End
Item	Trim / Thin Trees			37.890108 °	37.890108 °
				-121.329523 °	-121.329523 °
DWR ID	DWR_RD0524_01_s_2012_67				
Comment Code					
T1 : Trim trees to at least five feet above ground level.					
Inspector Comment					
Fig tree at landside toe.

Looking northwest at untrimmed tree on landward slope.

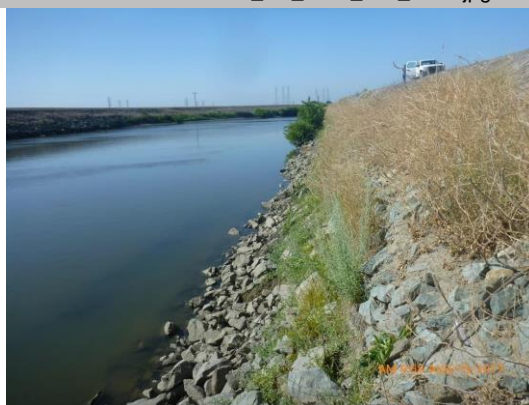
Photo 1 of 3 : LEVAL\_SP\_2019\_523\_4217.jpg

LM Start	4.76	Rating **	A/W	Issue No.	236
LM End	4.76	Issue Type +	Ma	Location *	
Category	Supplemental			GPS Latitude/Longitude	
				Start	End
Item	2017 Storm Damage			37.889300 °	37.889300 °
				-121.329800 °	-121.329800 °
DWR ID	DWR_RD0524_01_f_2017_236				
Comment Code					
Inspector Comment					
Levee Evaluation Comments					
Description:Slope protection repairs are needed along the waterside slope due to erosion and riprap displacement from high water. Based upon levee inspections, it was determined the waterside levee slope is eroding, deteriorating, and degrading. The eroded levee sections need to be restored back to design standards to prevent further deterioration and damage.					
Site ID No:523					
Site Designation:LMA-429					
Repair Type: Erosion					
Rating:Area of Concern					
Field Date:8/15/2017					
Notes:

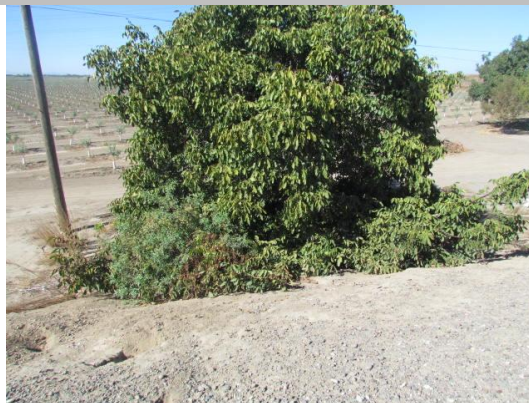
Photo 1 of 1 : SP\_2019\_RD0524\_107\_84\_20190313\_00116.jpg

LM Start	4.90	Rating **	M	Issue No.	84
LM End	4.93	Issue Type +	Ma	Location *	LS
Category	Earthen Levee			GPS Latitude/Longitude	
				Start	End
Item	Trim / Thin Trees			37.887613 °	37.887258 °
				-121.331161 °	-121.331596 °
DWR ID	DWR_RD0524_01_s_2012_84				
Comment Code					
T1 : Trim trees to at least five feet above ground level.					
Inspector Comment					
Untrimmed trees on landside slope.

Looking west at untrimmed tree on landward slope.

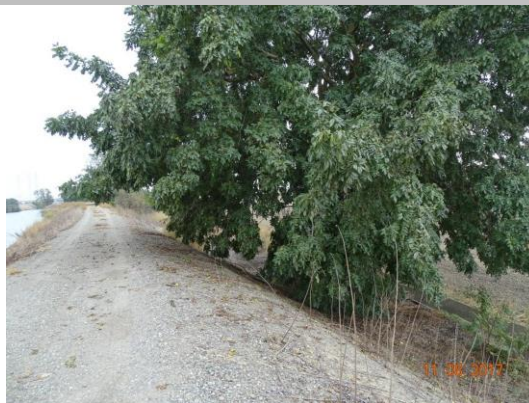
Photo 1 of 1 : SP\_2019\_RD0524\_107\_260\_20190313\_00270.jpg

LM Start	5.00	Rating **	M	Issue No.	260
LM End	5.00	Issue Type +	Ma	Location *	LS
Category	Earthen Levee			GPS Latitude/Longitude	
				Start	End
Item	Trim / Thin Trees			37.886367 °	37.886367 °
				-121.332047 °	-121.332047 °
DWR ID	DWR_RD0524_01_f_2017_260				
Comment Code					
T4 : Trim trees over roadway to at least 12 feet above ground level.					
Inspector Comment

Looking southwest at the landside slope.

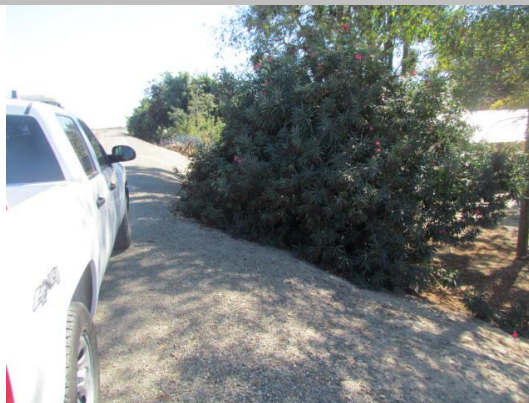
Photo 1 of 1 : SP\_2019\_RD0524\_107\_188\_20190313\_00191.jpg

LM Start	5.05	Rating **	M	Issue No.	188
LM End	5.07	Issue Type +	Ma	Location *	LS
Category	Earthen Levee			GPS Latitude/Longitude	
				Start	End
Item	Trim / Thin Trees			37.885673 °	37.885315 °
				-121.332122 °	-121.332139 °
DWR ID	DWR_RD0524_01_s_2014_188				
Comment Code					
T1 : Trim trees to at least five feet above ground level.					
Inspector Comment					
Untrimmed trees on landside slope and toe.

Looking south at oleander on landward slope.

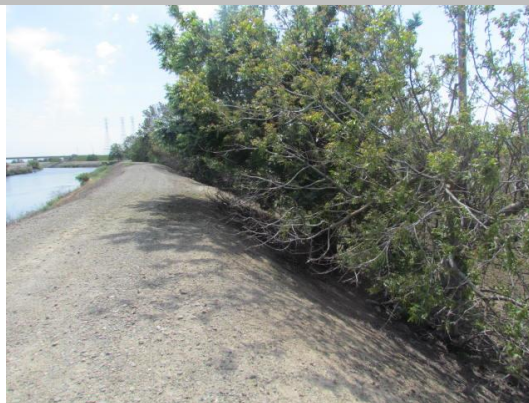
Photo 1 of 1 : SP\_2019\_RD0524\_107\_85\_20190313\_00117.jpg

LM Start	5.28	Rating **	M	Issue No.	85
LM End	5.34	Issue Type +	Ma	Location *	LS
Category	Earthen Levee			GPS Latitude/Longitude	
				Start	End
Item	Trim / Thin Trees			37.882363 °	37.881511 °
				-121.332577 °	-121.332777 °
DWR ID	DWR_RD0524_01_s_2012_85				
Comment Code					
T1 : Trim trees to at least five feet above ground level.					
Inspector Comment

Looking south at untrimmed trees on landward slope.

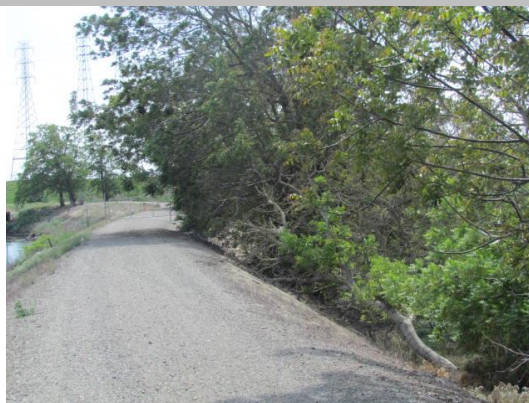
Photo 1 of 1 : SP\_2019\_RD0524\_107\_932\_20190313\_00295.jpg

LM Start	5.38	Rating **	M	Issue No.	932
LM End	5.41	Issue Type +	Ma	Location *	LS
Category	Earthen Levee			GPS Latitude/Longitude	
				Start	End
Item	Trim / Thin Trees			37.880945 °	37.880522 °
				-121.332837 °	-121.332918 °
DWR ID	DWR_RD0524_01_s_2012_932				
Comment Code					
T1 : Trim trees to at least five feet above ground level.					
Inspector Comment

Looking south at untrimmed trees on landward slope and toe.

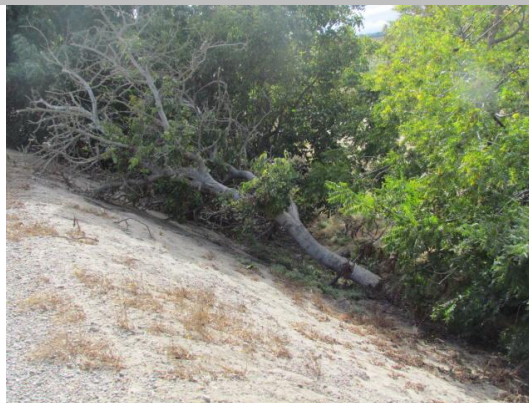
Photo 1 of 1 : SP\_2019\_RD0524\_107\_178\_20190313\_00182.jpg

LM Start	5.39	Rating **	M	Issue No.	178
LM End	5.39	Issue Type +	Ma	Location *	LS
Category	Earthen Levee			GPS Latitude/Longitude	
				Start	End
Item	Encroachments			37.880806 °	37.880806 °
				-121.332833 °	-121.332833 °
DWR ID	DWR_RD0524_01_f_2014_178				
Comment Code					
TR : Tree or limb					
Inspector Comment					
Downed tree on landside toe.

Looking south at downed tree on landward slope.

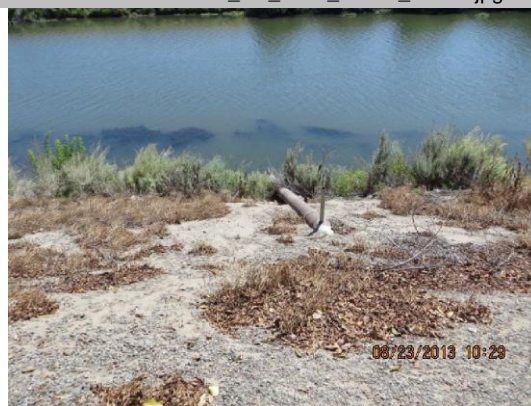
Photo 1 of 3 : UCIP\_SP\_2019\_53358\_30689.jpg

Comment Code					
Inspector Comment					
FS_ID:53358 DS_ID:20630 EP_NO: N/A Repair Type: Urgent Crossing Status: Found UCIP Comments: 10/2/2018 Same as last inspection. Holes present in pipe pose a potential threat to levee's internal integrity. Recommend video inspection (D. Sanoski - DWR UCIP).11/16/2016 same as previous inspection hole in pipe is still present on WS near toe. This pipe does not appear to be in use. Need to contact owner to determine status of crossing. If the crossing is abandoned or still in use, owner will need to coordinate with the CVFPB to comply with Title 23 requirements. (O. Magana - DWR UCIP)08/23/2013 flap gate damage and does not work at WS toe. Large hole in pipe at WS toe. Pipe appears abandoned and should be done so properly. (W. Wylie - DWR UCIP) FIELD_STRUCT_DESC: *ABANDONED* 1 of 2: 12-inch steel irrigation pipe through the levee, 6 feet below the crown. Pump located on the waterside (WS), no pump found in 2013. Flap gate located on the WS end. [Additional Reference(s): DWR Levee Log, 2004. USACE San Joaquin O&M Manual 7, April 1964, (HLM 5.48) 10-inch pipe listed, Drawing No. 07-04-1490, Sheet 1490/4, (Station 8+01.3)]. FS Date: 10/2/2018 1:34:00 PM

Pipe visible on WS slope.

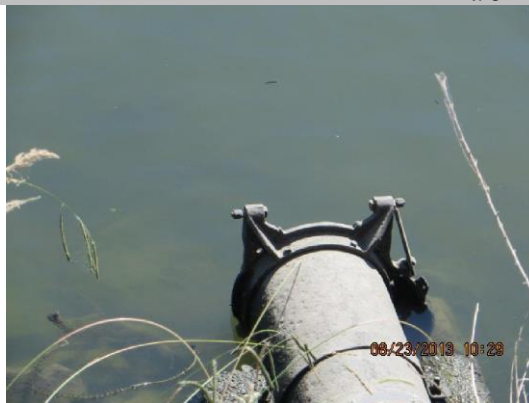
Photo 3 of 3 : UCIP\_SP\_2019\_53358\_30687.jpg

Comment Code						
Inspector Comment						
FS_ID:53358 DS_ID:20630 EP_NO: N/A Repair Type: Urgent Crossing Status: Found UCIP Comments: 10/2/2018 Same as last inspection. Holes present in pipe pose a potential threat to levee's internal integrity. Recommend video inspection (D. Sanoski - DWR UCIP).11/16/2016 same as previous inspection hole in pipe is still pressent on WS near toe. This pipe does not appear to be in use. Need to contact owner to determine status of crossing. If the crossing is abandoned or still in use, owner will need to coordinate with the CVFPB to comply with Title 23 requirements. (O. Magana - DWR UCIP)08/23/2013 flap gate damage and does not work at WS toe. Large hole in pipe at WS toe. Pipe appears abandoned and should be done so properly. (W. Wylie - DWR UCIP) FIELD_STRUCT_DESC: *ABANDONED* 1 of 2: 12-inch steel irrigation pipe through the levee, 6 feet below the crown. Pump located on the waterside (WS), no pump found in 2013. Flap gate located on the WS end. [Additional Reference(s): DWR Levee Log, 2004. USACE San Joaquin O&M Manual 7, April 1964, (HLM 5.48) 10-inch pipe listed, Drawing No. 07-04-1490, Sheet 1490/4, (Station 8+01.3)]. FS Date: 10/2/2018 1:34:00 PM

Broken flap gate at WS toe.

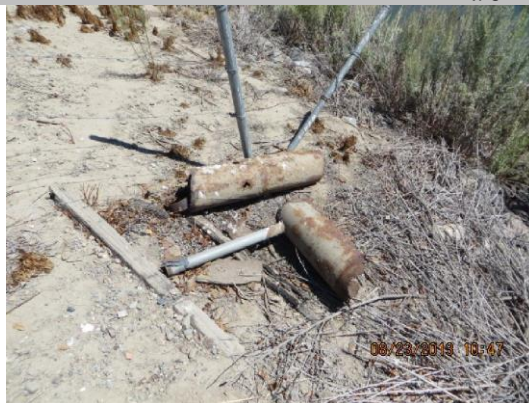
Photo 1 of 3 : UCIP\_SP\_2019\_18348\_30706.jpg

LM Start	5.42	Rating **	M	Issue No.	963
LM End	5.42	Issue Type +	Ma	Location *	
Category	Supplemental			GPS Latitude/Longitude	
				Start	End
Item	DWR UCIP LMA Responsibility			37.880358 °	37.880358 °
				-121.332972 °	-121.332972 °
DWR ID	20631				
Comment Code					
Inspector Comment					
FS_ID:18348					
DS_ID:20631					
EP_NO: N/A					
Repair Type: Non-Urgent					
Crossing Status: Found					
UCIP Comments: Recent work being done on WS slope. Pipe may still be in use.					
FIELD_STRUCT_DESC: 10-inch steel drainage pipe through the levee, 6 feet below the crown. Pump not found on the landside (LS).					
[Additional Reference(s): DWR Levee Log, 2004. USACE San Joaquin O&M Manual 7, April 1964, (HLM 5.50)].					
FS Date: 8/23/2013

10-inch pipe debris on the WS slope.

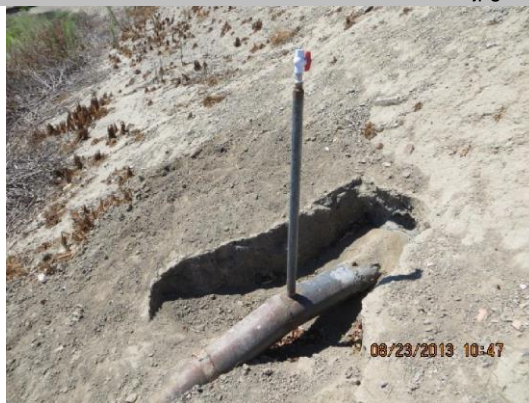
Photo 2 of 3 : UCIP\_SP\_2019\_18348\_30705.jpg

8-inch pipe sleeved through 10-inch pipe with vent on WS slope.

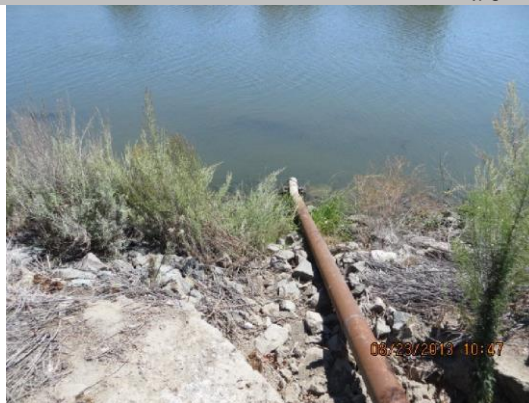
Photo 3 of 3 : UCIP\_SP\_2019\_18348\_30704.jpg

LM Start	5.42	Rating **	M	Issue No.	963 (cont)	
LM End	5.42	Issue Type +	Ma	Location *		
Category	Supplemental			GPS Latitude/Longitude		
				Start	End	
Item	DWR UCIP LMA Responsibility			37.880358 °	37.880358 °	
				-121.332972 °	-121.332972 °	
DWR ID	20631					
Comment Code						
Inspector Comment						
FS_ID:18348						
DS_ID:20631						
EP_NO: N/A						
Repair Type: Non-Urgent						
Crossing Status: Found						
UCIP Comments: Recent work being done on WS slope. Pipe may still be in use.						
FIELD_STRUCT_DESC: 10-inch steel drainage pipe through the levee, 6 feet below the crown. Pump not found on the landside (LS).						
[Additional Reference(s): DWR Levee Log, 2004. USACE San Joaquin O&M Manual 7, April 1964, (HLM 5.50)].						
FS Date: 8/23/2013

No flap gate on end of pipe at WS toe.

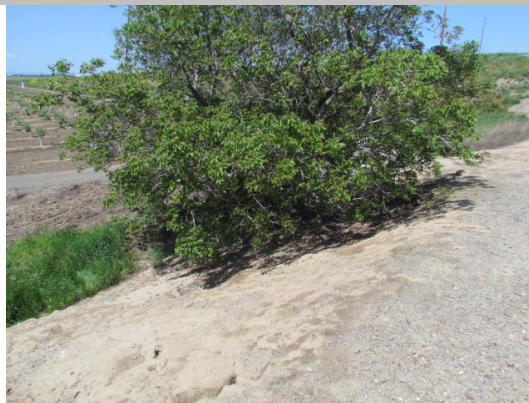
Photo 1 of 1 : SP\_2019\_RD0524\_107\_117\_20190313\_00145.jpg

LM Start	5.66	Rating **	M	Issue No.	117
LM End	5.66	Issue Type +	Ma	Location *	LS
Category	Earthen Levee			GPS Latitude/Longitude	
				Start	End
Item	Trim / Thin Trees			37.877100°	37.877100°
				-121.332323°	-121.332323°
DWR ID	DWR_RD0524_01_f_2013_117				
Comment Code					
T1 : Trim trees to at least five feet above ground level.					
Inspector Comment

Looking northwest at untrimmed tree on landward slope.

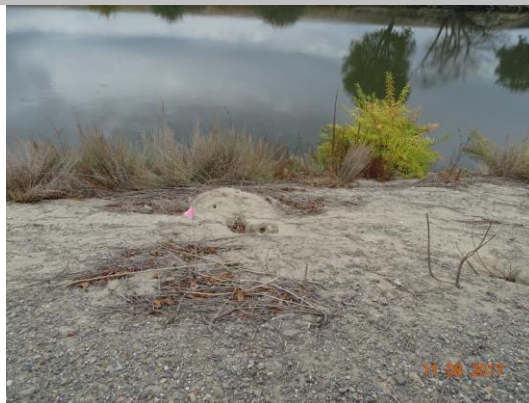
Photo 1 of 1 : SP\_2019\_RD0524\_107\_271\_20190313\_00283.jpg

LM Start	5.76	Rating **	M	Issue No.	271
LM End	5.76	Issue Type +	Ma	Location *	WS
Category	Earthen Levee			GPS Latitude/Longitude	
				Start	End
Item	Animal Control			37.875631 °	37.875631 °
				-121.332907 °	-121.332907 °
DWR ID	DWR_RD0524_01_f_2017_271				
Comment Code					
A3 : No rodents visible, but rodent burrows visible; need to backfill and compact or grout burrows.					
Inspector Comment

Looking east at the waterside slope.

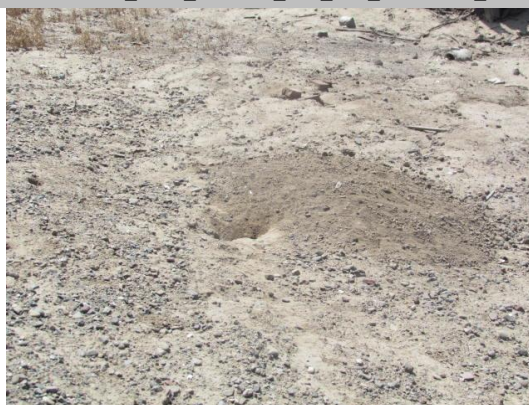
Photo 1 of 2 : SP\_2019\_RD0524\_107\_197\_20190313\_00201.jpg

LM Start	5.77	Rating **	A/W	Issue No.	197
LM End	5.79	Issue Type +	Ma	Location *	LS
Category	Earthen Levee			GPS Latitude/Longitude	
				Start	End
Item	Animal Control			37.875545 °	37.875310 °
				-121.332952 °	-121.333065 °
DWR ID	DWR_RD0524_01_s_2015_197				
Comment Code					
A1 : Exterminate rodents and backfill and compact or grout burrows.					
Inspector Comment					
Several rodent holes on landside slope and levee crown. LMA Backfilled hole but no rodent control measures are in place.

Looking north at typical view of rodent holes on landward slope.

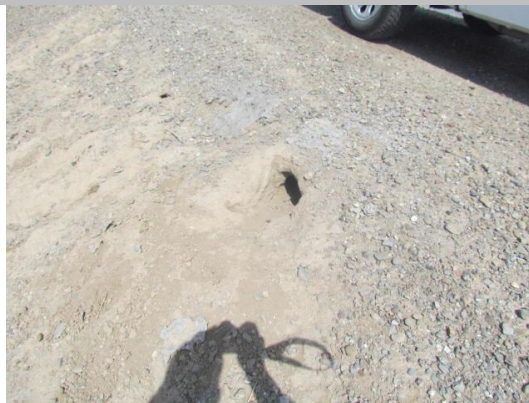
Photo 2 of 2 : SP\_2019\_RD0524\_107\_197\_20190313\_00202.jpg

Looking southwest at typical view of rodent hole at landward shoulder.

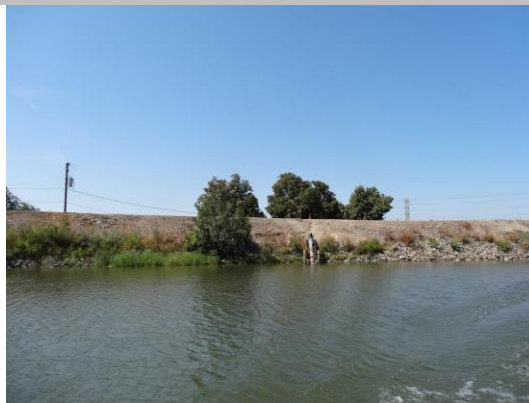
Photo 1 of 2 : SP\_2019\_RD0524\_107\_93\_20190313\_00125.jpg

LM Start	5.86	Rating **	U	Issue No.	93
LM End	5.86	Issue Type +	Ma	Location *	WS
Category	Supplemental			GPS Latitude/Longitude	
				Start	End
Item	DWR Erosion Survey			37.874370 °	37.874370 °
				-121.332850 °	-121.332850 °
DWR ID	RD0524U01RM46.39				
Comment Code					
Inspector Comment					
09/13/2017: No significant change observed.					
07/25/2016: No significant change observed.					
06/24/2015: No significant change observed.					
06/19/2014: No significant change observed.					
08/13/2013: No significant change observed.					
08/07/2012: The erosion is near a water-intake structure. Pipe leakage likely caused the erosion. [2017 Site ID:RD0524U01RM46.39]

Front view of the site.

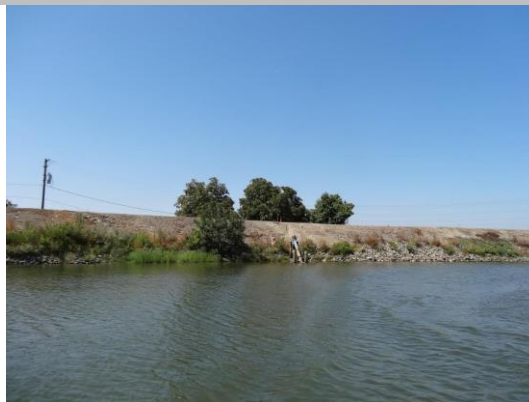
Photo 2 of 2 : SP\_2019\_RD0524\_107\_93\_20190313\_00126.jpg

View of the erosion.

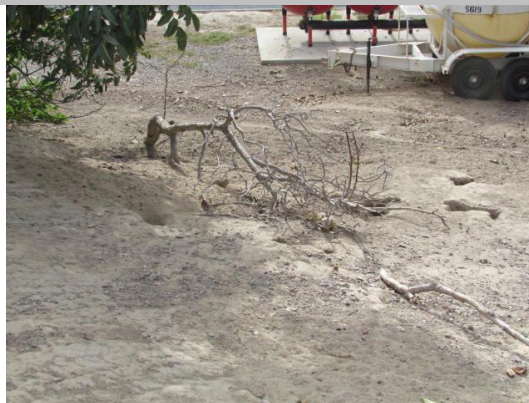
Photo 1 of 2 : SP\_2019\_RD0524\_107\_75\_20190313\_00103.jpg

LM Start	5.86	Rating **	M	Issue No.	75
LM End	5.88	Issue Type +	Ma	Location *	WS
Category	Earthen Levee			GPS Latitude/Longitude	
				Start	End
Item	Animal Control			37.874240 °	37.874002 °
				-121.333187 °	-121.333027 °
DWR ID	DWR_RD0524_01_s_2012_75				
Comment Code					
A1 : Exterminate rodents and backfill and compact or grout burrows.					
Inspector Comment					
District has grouted rodent holes, but other rodent holes have appeared. Active rodents in area.

Looking typical view of several rodent holes on landward slope and toe.

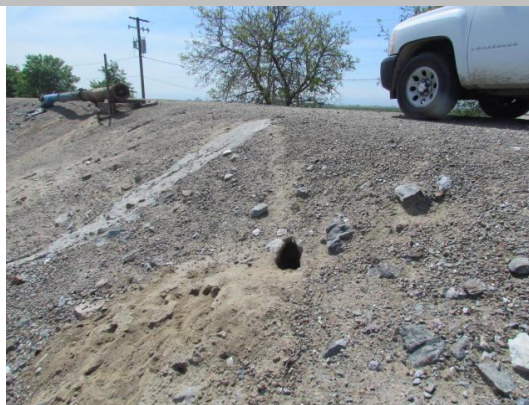
Photo 2 of 2 : SP\_2019\_RD0524\_107\_75\_20190313\_00104.jpg

Looking southwest at typical rodent holes on waterward slope.

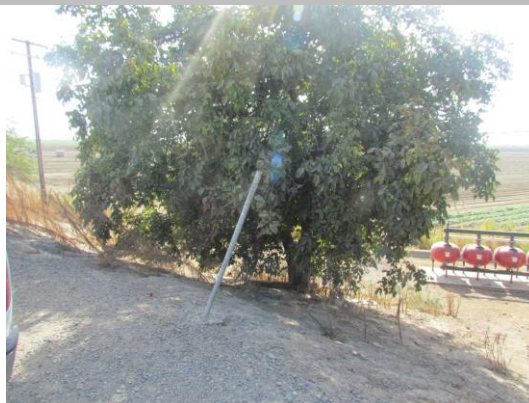
Photo 1 of 1 : SP\_2019\_RD0524\_107\_98\_20190313\_00132.jpg

LM Start	5.87	Rating **	M	Issue No.	98
LM End	5.87	Issue Type +	Ma	Location *	LS
Category	Earthen Levee			GPS Latitude/Longitude	
				Start	End
Item	Trim / Thin Trees			37.874085 °	37.874085 °
				-121.333154 °	-121.333154 °
DWR ID	DWR_RD0524_01_s_2012_98				
Comment Code					
T1 : Trim trees to at least five feet above ground level.					
Inspector Comment					
Untrimmed walnut tree on landside slope.

Looking west at walnut tree on landward slope.

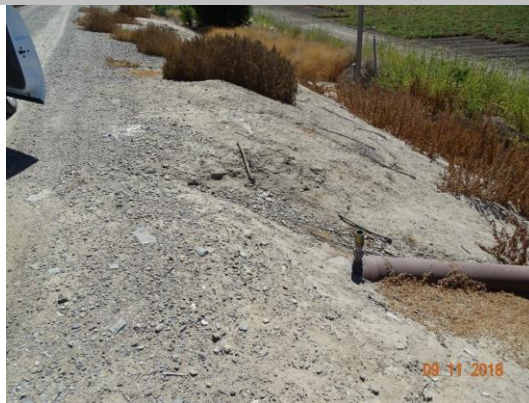
Photo 1 of 1 : SP\_2019\_RD0524\_107\_147\_20190313\_00148.jpg

LM Start	6.08	Rating **	M	Issue No.	147
LM End	6.08	Issue Type +	Ma	Location *	LS
Category	Earthen Levee			GPS Latitude/Longitude	
				Start	End
Item	Erosion / Bank Caving			37.872017 °	37.872017 °
				-121.330487 °	-121.330487 °
DWR ID	DWR_RD0524_01_f_2018_147				
Comment Code					
E1 : Note and monitor erosion site.					
Inspector Comment					
Erosion around and near pipe on landward slope.

Looking at landward erosion. (Fall 2018)

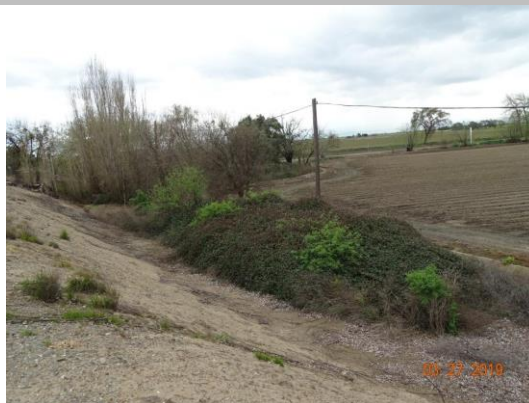
Photo 1 of 1 : SP\_2019\_RD0524\_107\_142\_20190328\_00394.jpg

LM Start	6.11	Rating **	U	Issue No.	142
LM End	6.11	Issue Type +	Ma	Location *	LS
Category	Earthen Levee			GPS Latitude/Longitude	
				Start	End
Item	Vegetation			37.871631 °	37.871631 °
				-121.330332 °	-121.330332 °
DWR ID	DWR_RD0524_01_s_2019_142				
Comment Code					
V2 : Remove the wild growth other than native grasses from the levee slopes.					
Inspector Comment					
Dense vegetation within landside easement blocking visibility.

Dense vegetation on landside toe. Spring 2019.

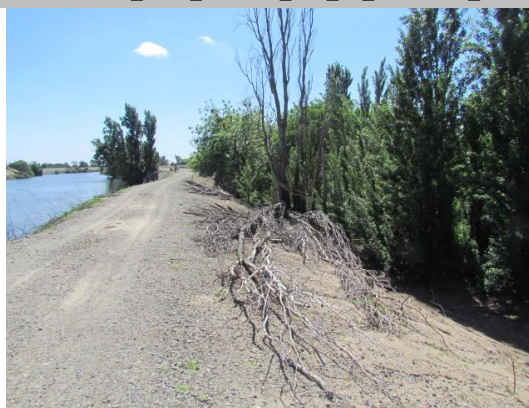
Photo 1 of 2 : SP\_2019\_RD0524\_107\_81\_20190313\_00113.jpg

LM Start	6.15	Rating **	M	Issue No.	81
LM End	6.15	Issue Type +	Ma	Location *	LS
Category	Earthen Levee			GPS Latitude/Longitude	
				Start	End
Item	Encroachments			37.871097 °	37.871097 °
				-121.330100 °	-121.330100 °
DWR ID	DWR_RD0524_01_s_2015_81				
Comment Code					
TR : Tree or limb					
Inspector Comment					
Fallen tree branches and limbs on landside slope.

Looking south at tree branches and limbs left on landward shoulder and slope. (Spring 2016)

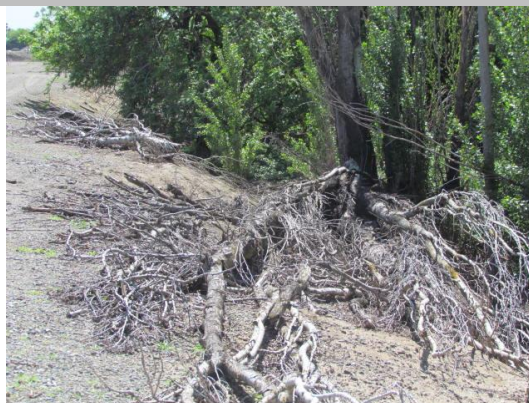
Photo 2 of 2 : SP\_2019\_RD0524\_107\_81\_20190313\_00114.jpg

Looking west at tree branches and limbs left on landward shoulder and slope. (Spring 2016)
